The Restoration of the Baha'i House of Worship

Wilmette, IL

Submitted by The Armbruster Company

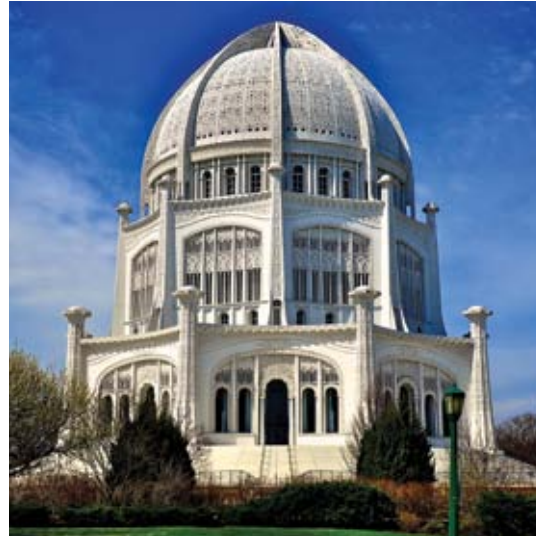
Twenty years after repairs, the Baha'i House of Worship's exquisite beauty continues to sparkle in the sunlight and dazzle hundreds of thousands of visitors each year

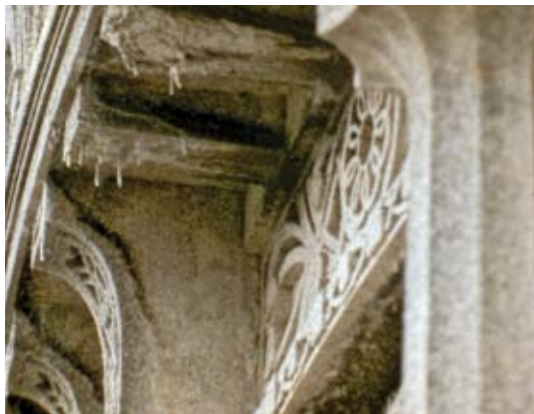
Most of the ornamental concrete in the area along the cornice, soffit, and dentils of the clerestory appeared to be in good condition, with some deterioration. In addition, steel anchors of the ornamental concrete to the structure were fractured as a result of expansion due to water infiltration and freezing.

A gap of up to 1 in. (25 mm) was found where the white ornamental concrete had originally been in contact with the underlying structural concrete. Petrographic analysis of the samples showed that the structural concrete was damaged as much as 30 in. (762 mm) below the surface, even where the ornamental concrete appeared sound. The damage did not affect the overall strength of the building's structure, but it weakened the support for the ornamental concrete.

Small jackhammers were used to remove the damaged ornamental concrete at the crown. The deteriorated structural concrete was then removed down to sound concrete, which was 3 ft (1 m) deep in some places.

Each of the crown's nine sides extends 31 ft (9.5 m) wide and 5 ft (1.5 m) high. In each of the sides, the craftsmen drilled and set 240 new 3 ft (0.9 m) long steel anchors in epoxy. Epoxy-coated steel reinforcing rods were carefully fit behind curved forms.

To repair the crown or clerestory cornice, technicians removed deteriorated architectural concrete and structural concrete. The finished repair matched the original

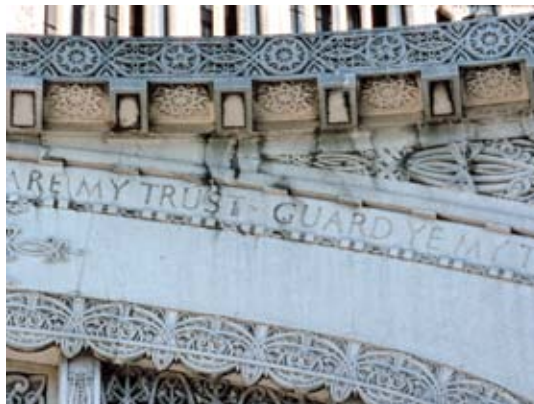
These black crusts were formed when sulfur dioxide gas came in contact with the moist concrete surface containing calcite compounds. The chemical reaction created gypsum crystals that formed

Before the cleaning began in 1989, the temple was covered with black crusts of gypsum crystals, organic growths, and extensive stains of atmospheric pollution

around other pollutants. Although the crusts were extremely hard, they were slightly water soluble. They were removed in 1989 by dissolving them with a fine mist of water sprayed from modular manifolds custom built to fit each unique architectural feature. The water supply was controlled by timers programmed to spray in cycles of 5 minutes on and 20 minutes off. This not only saved water, but also reduced the risk of water penetrating the walls, where it might have damaged the interior.

Efflorescence, visible on the temple as white crusts and stalactites, were removed with a water mist and gentle brushing. The black scabs and white stalactites covered only a small portion of the building, however. The largest task was removing the staining caused by atmospheric pollution. The quartz stones were covered with blackish stains and there were also organic growths rooted in the cement and sand matrix between the large aggregate. After numerous tests and laboratory analyses, a specially formulated restoration cleaning solution was selected to pre-soften the stains and kill the organic growths.
