Approach to Preservation of Historic Concrete

by Ann Harrer, Paul Gaudette, and Deborah Slaton

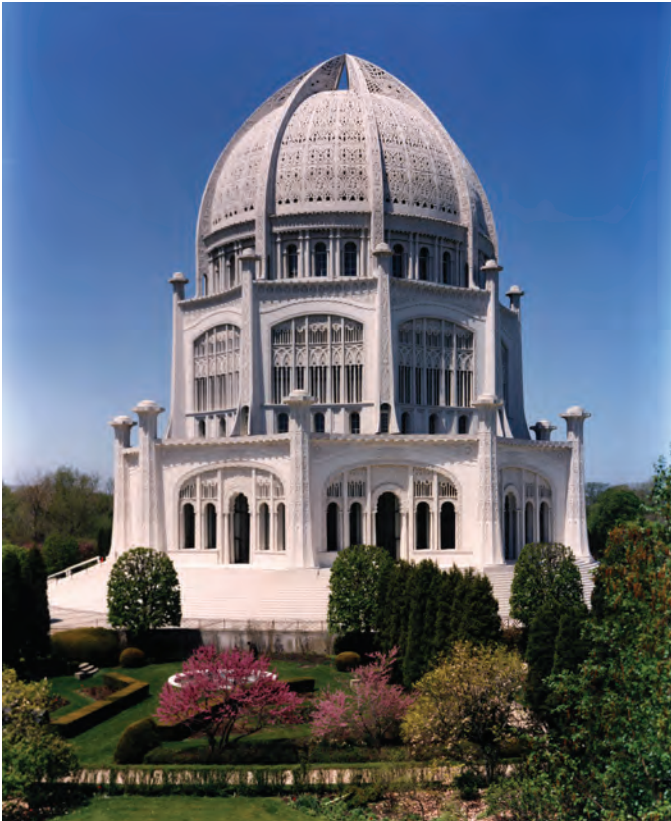
Fig. 1: Architectural precast concrete at the Bahai Temple in Chicago, Illinois, designed by Louis Bourgeois and John J. Earley

John J. Earley's work exemplified the creativity and aesthetics that can be achieved by utilizing exposed aggregates in architectural precast panels (Fig. 1). Architects such as Frank Lloyd Wright, Le Corbusier (Fig. 2), Louis Kahn (Fig. 3), and many others incorporated concrete as architectural elements in their designs.

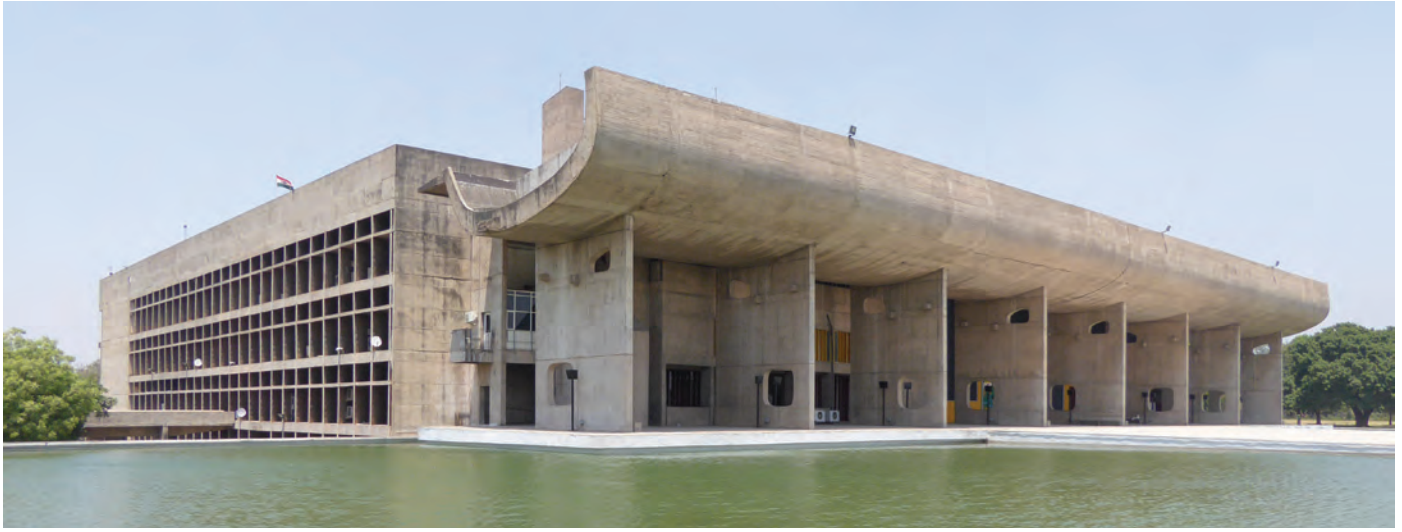
Fig. 2: Exposed concrete finish at the Legislative Assembly in Chandigarh, India, designed by Le Corbusier

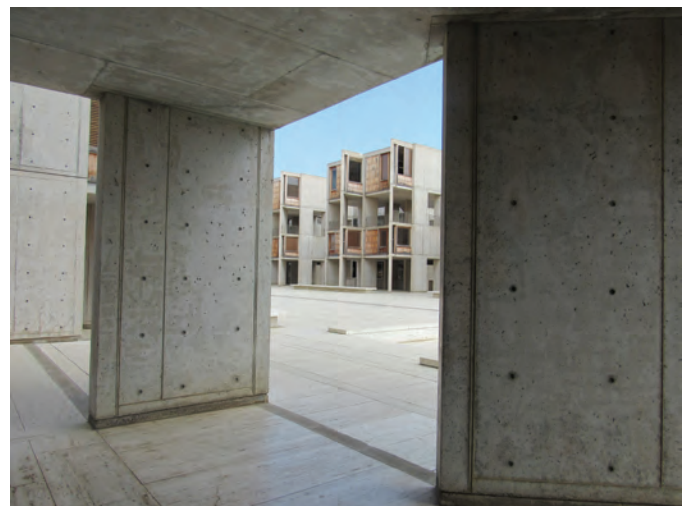
Fig. 3: Exposed concrete finish at the Salk Institute for Biological Studies in La Jolla, California, designed by Louis Kahn

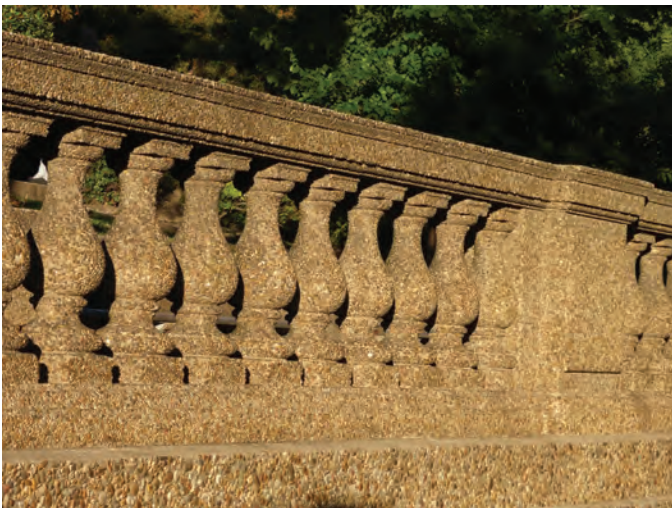
Fig. 5: Exposed aggregate at a historic concrete balustrade

As the popularity of concrete as an architectural material grew in the early twentieth century, architects and engineers experimented with various possibilities for form, finish, and texture. In addition, precasters and sculptors also realized that concrete offered benefits and opportunities. By varying the amount and type of material constituents, including the aggregates and cements, the material properties and color of the concrete can be adjusted (Fig. 5). Some of the finishing techniques used historically, as well as currently, include exposing the aggregates, rubbing to create a smooth finish, and retaining the texture from the formwork in the finish (board form) (Fig. 6).

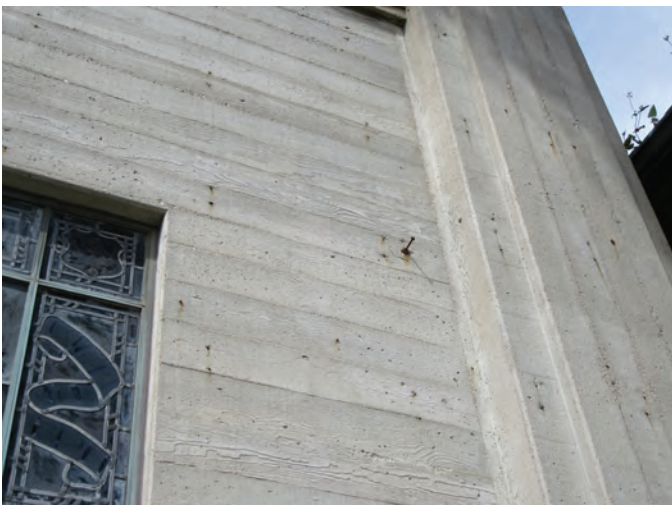
Fig. 6: Variations in formwork and finish at a historic concrete facade

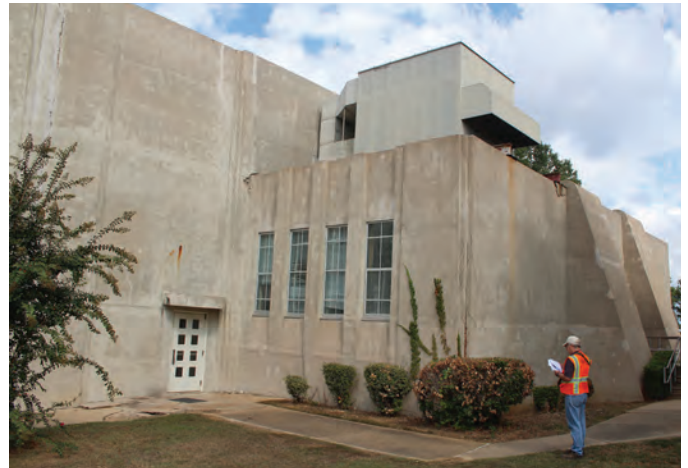
Fig. 7: Ongoing condition assessment of a historic concrete building facade

and determine causes of distress and deterioration (Fig. 7). The findings of the assessment provide the basis for development of a rehabilitation strategy that typically includes a repair and maintenance program. The condition assessment should include, at a minimum: identification of significant character-defining features, research and document review, field investigation, and (as appropriate) field and laboratory testing.

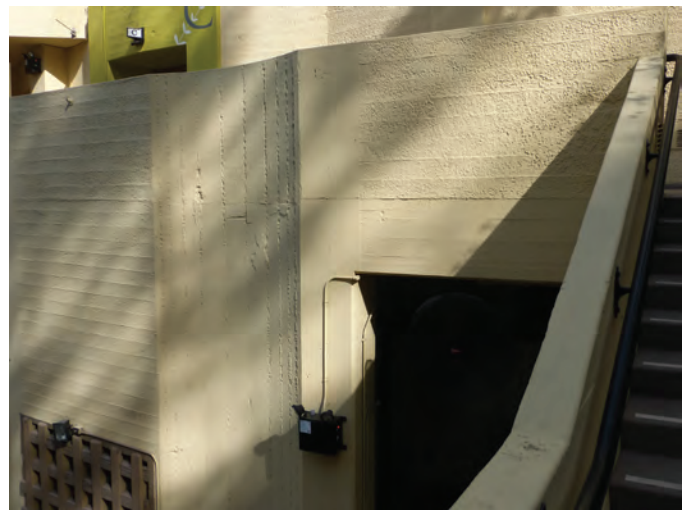
Fig. 8: Due to variations in formwork and finishing techniques, there are visible differences in texture, even after a coating has been applied

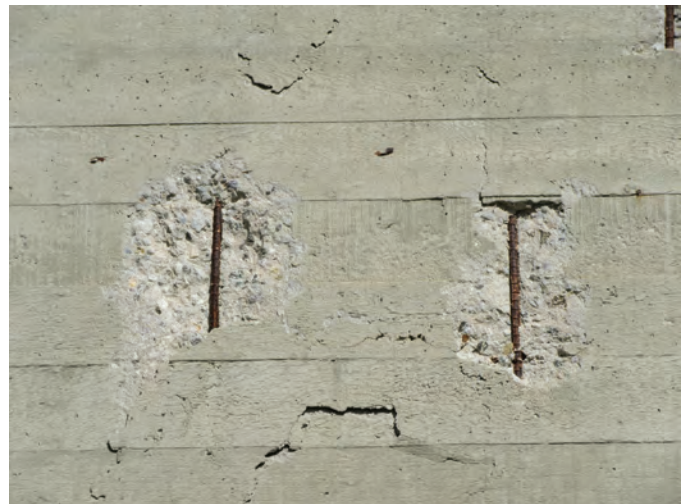
Fig. 9: Delamination and spalling at exposed concrete are examples of distress and deterioration that should be documented as part of a visual condition survey

As conditions that contribute to deterioration and distress within concrete structures are often not visible, the use of inspection openings can verify conditions from the visual survey, sounding, and nondestructive testing. Locations for inspection openings should be representative of the various conditions noted during the survey and should be unobtrusive if possible, especially on historic structures. Locating inspection openings in areas of existing distress (cracks or spalls) can provide information while minimizing the removal of material (Fig. 9).

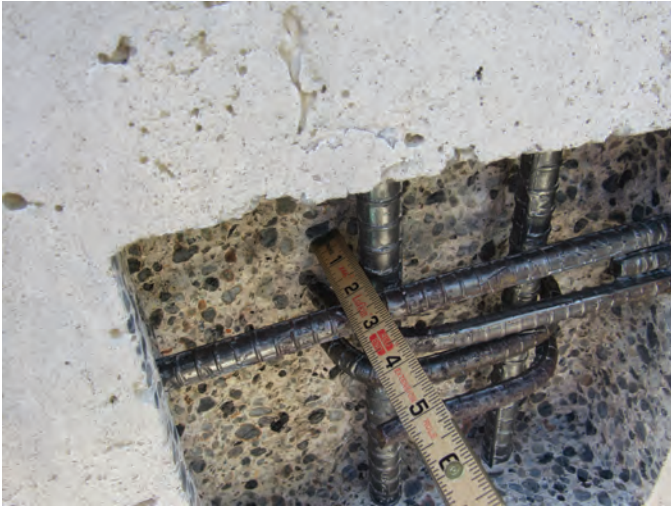
Fig. 10: Removal of concrete beyond the corroding reinforcement bar to allow for removal of corrosion product and to address the underlying distress mechanism

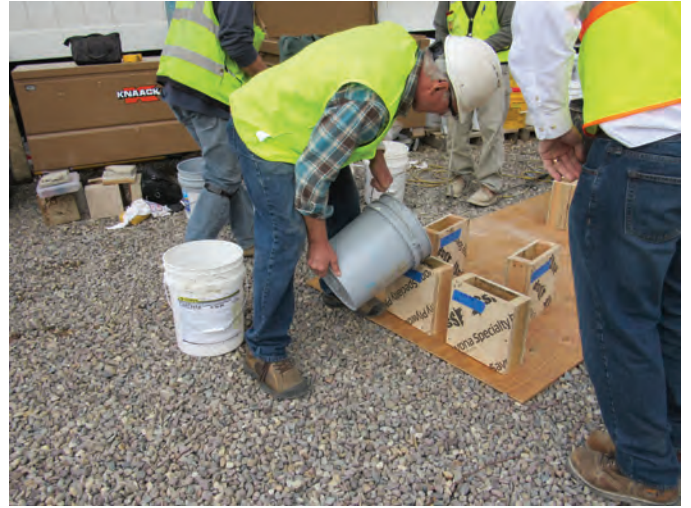
Fig. 11: Completion of off-building trial samples and mock-ups prior to the start of repairs to confirm appropriate performance of the concrete mix design, placement procedures, and finishing techniques

The results of architectural concrete repair work are dependent to a great extent on the experience and craftsmanship of the craftsman performing the work. As craftsmanship is critical to the overall technical performance as well as the final aesthetic of the repairs, it is imperative that the desired level of craftsmanship be established prior to the start of work through mock-ups and a trial repair program. Mock-ups and trial repairs are also necessary to confirm the developed conservation approach, provide an opportunity to refine the repair process, and provide an opportunity for the owner, design team, and contractor to review examples of the completed repair (Fig. 11).
