The Restoration of the Baha'i House of Worship

Wilmette, IL

Submitted by The Armbruster Company

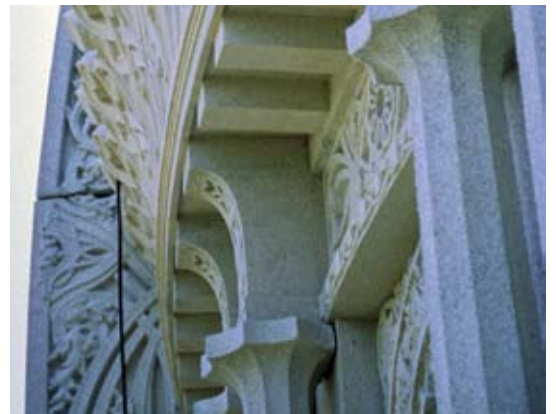
These black crusts were formed when sulfur dioxide gas came in contact with the moist concrete surface containing calcite compounds. The chemical reaction created gypsum crystals that formed

around other pollutants. Although the crusts were extremely hard, they were slightly water soluble. They were removed in 1989 by dissolving them with a fine mist of water sprayed from modular manifolds custom built to fit each unique architectural feature. The water supply was controlled by timers programmed to spray in cycles of 5 minutes on and 20 minutes off. This not only saved water, but also reduced the risk of water penetrating the walls, where it might have damaged the interior.

Before the cleaning began in 1989, the temple was covered with black crusts of gypsum crystals, organic growths, and extensive stains of atmospheric pollution
